TECHNICAL ALERT

May 16, 2002

PK543 Amplifiers and Lobby Speakers

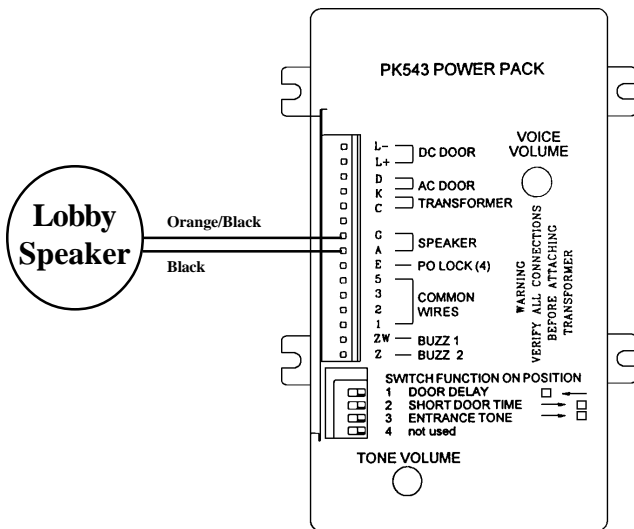
THE RIGHT WAY

Here is what is happening.... on the newest PK543 amplifiers a new wire has been added to the wiring harness between the Orange and Orange/Black wires. This new wire is a White wire with a Black stripe. This White/Black wire is shown on the newest (IL487) wiring diagrams as terminal 'V', although the PK543 plastic cases were not yet printed with this new terminal 'V' between the 'C' and 'G' terminals. This White/Black 'V' wire is used only when the LI404B apartment strobe is connected to the PK543 amplifier, and is probably not used in 90+% of all installations. The correct way to connect the lobby speaker to the PK543 is to terminal 'G' and 'A' (Orange/Black and Black respectively). If the installer accidentally connects the lobby speaker to 'V' and 'G' (White/Black and Orange/Black respectively), even for a moment, the lobby speaker will blow, and there will be no voice on the system. Changing the speaker corrects this problem, and the PK543 is usually not harmed by the mis-wiring.

We have begun to place a warning label on the White/Black 'V' wires on PK543's we are now shipping in the hopes of avoiding this problem from now on. Please advise your installers of this situation right away. Thank you.

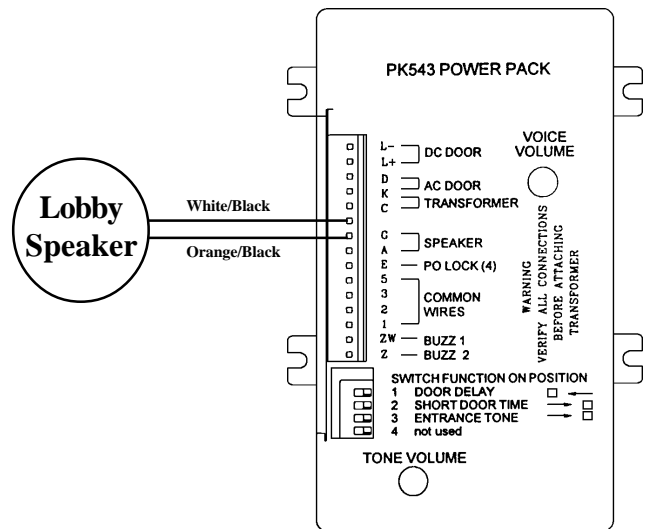
THE WRONG WAY

Recently we have had a number of customers call us and tell us that they received lobby entry panels with 'bad speakers'. After an exhaustive investigation, we found the problem was not 'bad speakers', but a problem with the way some installers wired the speakers to the PK543 amplifiers.
