SC-100 Field Calibration

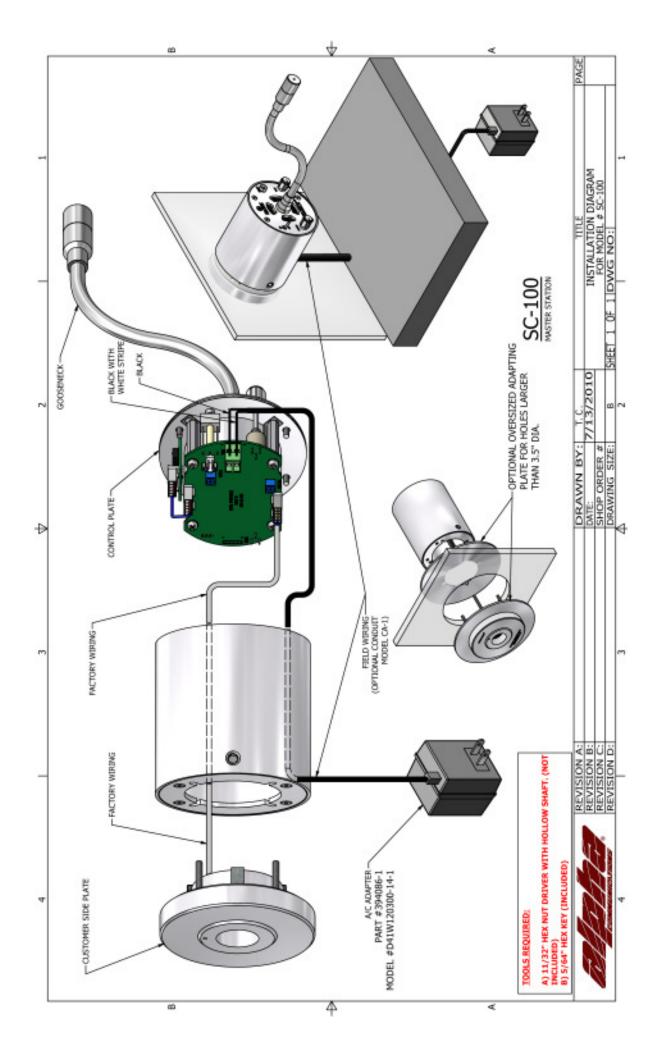
VR31 "master" or inside

VR26 gooseneck dominance.

DO NOT ADJUST! CONSULT THE FACTORY PRIOR TO ADJUST-MENT.

VR131 remote/outside

Symptom: conversation is "clipped"; conversations are cut short.

VR26 if adjusted clockwise, will allow the gooseneck/master side mic to dominate the outside microphone. If increased too much, the outside/remote will not be heard at all. Default position is at the 10:00 position

Solution: FIRST: NOTE ORIGINAL POSITION OF THE POTENTIOMETERS.

if inside operator's (IO)conversation is clipped, increase IO's microphone

sensitivity by turning R31 one (1) notch clockwise.

if outside operator's (OO) conversation is clipped, increase OO's microphone sensitivity by turning R131 one (1) notch clockwise.

Repeat if necessary.

NOTE: R31 and R131 are "balanced". Therefore, decreasing one microphone will have the same effect as increasing the other (it's all relative).

The control assembly must be placed back into the housing to perform correctly. Otherwise, feedback may occur.
